Department
Transportation
National Highway
Traffic Safety
Administration

OT HS 806 865
Final Report

September 1985

Side Impact Fixed-Pole Crash Testing of the NHTSA Modified Vehicle

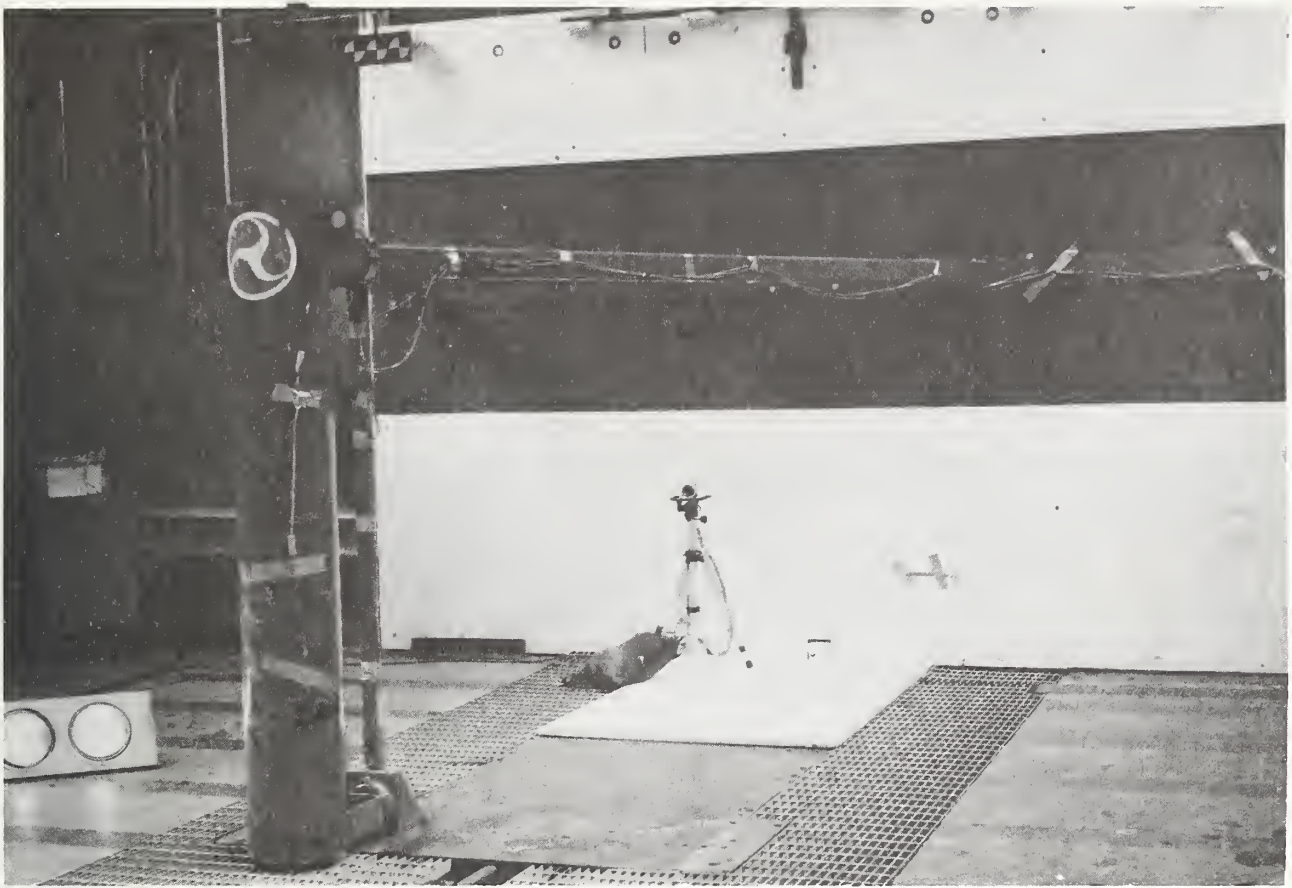
FIGURE 4.1 -- Overview of Pole-Test Hardware

In order to meet the parameters listed in the previous section in the conduct of these crash tests, it was necessary to build special hardware. First, a rigid pole was constructed from steel tubing with an outer diameter of 12 inches and a wall thickness of $3/8$ of an inch. This pole, filled with concrete, was mounted to the face of the immovable barrier wall at the TRCO (see figure 4.1). Four 50,000 pound load cells, two at the top of the pole, two at the base, were mounted such that the total force exerted on the pole in the direction of impact could be measured. The entire pole structure could be adjusted along the barrier wall so that impact location on the car could be changed.

As mentioned in the previous section, four 50,000 pound load cells were used to measure the force exerted on the pole in the direction of impact. Two of these were mounted at the top of the pole, two at the base.

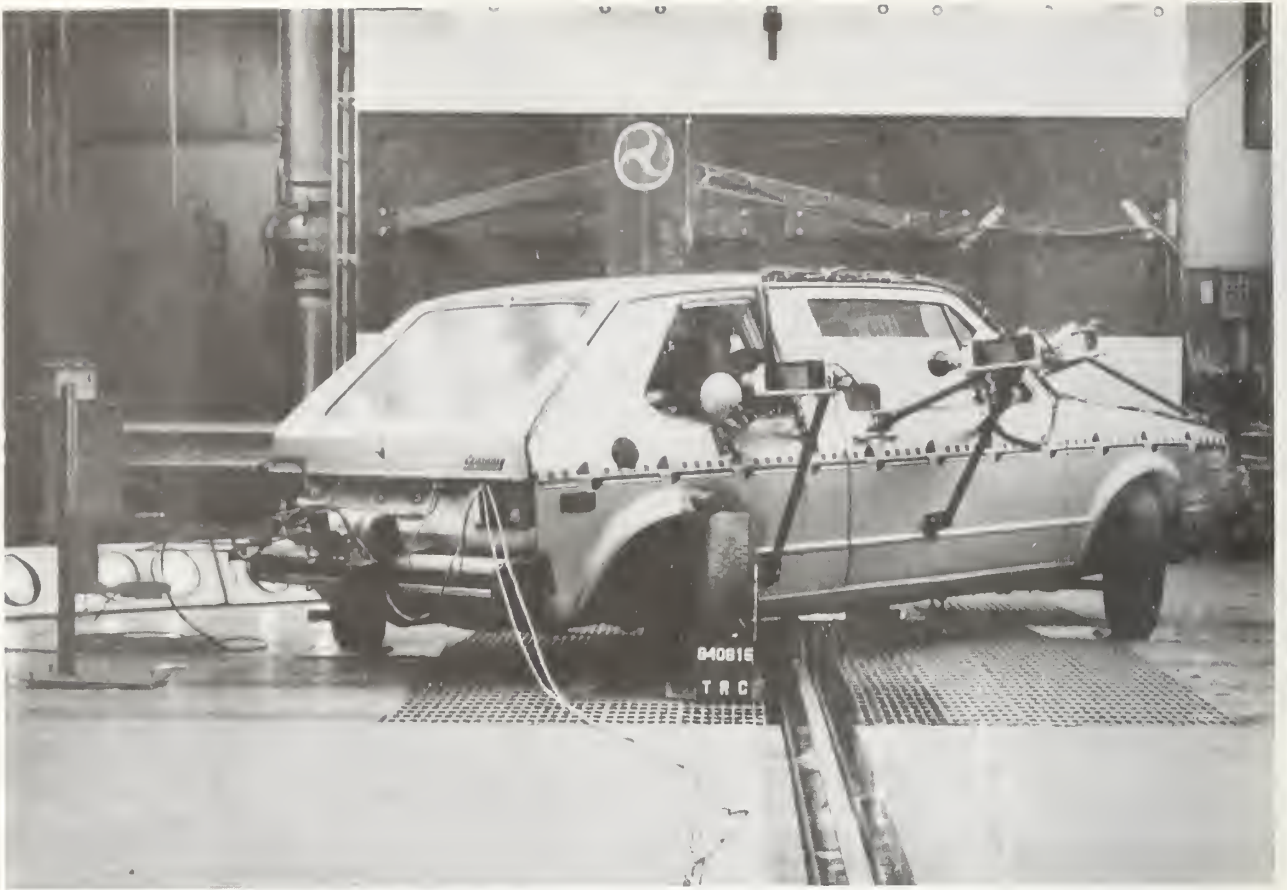
FIGURE 4.2 -- Vehicle Modifications for Angled Towing

To achieve an impact angle of 45° , a decision was made to turn all four wheels of the car, enabling it to roll at this angle (see figure 4.2). This was done to the front wheels by simply removing the tie rods, pivoting the wheels, and fastening them at the desired angle. Since the wheel wells for the rear tires would not allow this much movement, fixtures were constructed which extended the rear axle. The tires were then mounted on these fixtures at 45° . The above adjustments were made with the vehicle ballasted at test weight. If this was not done, wheel alignments would change when the weight was added.

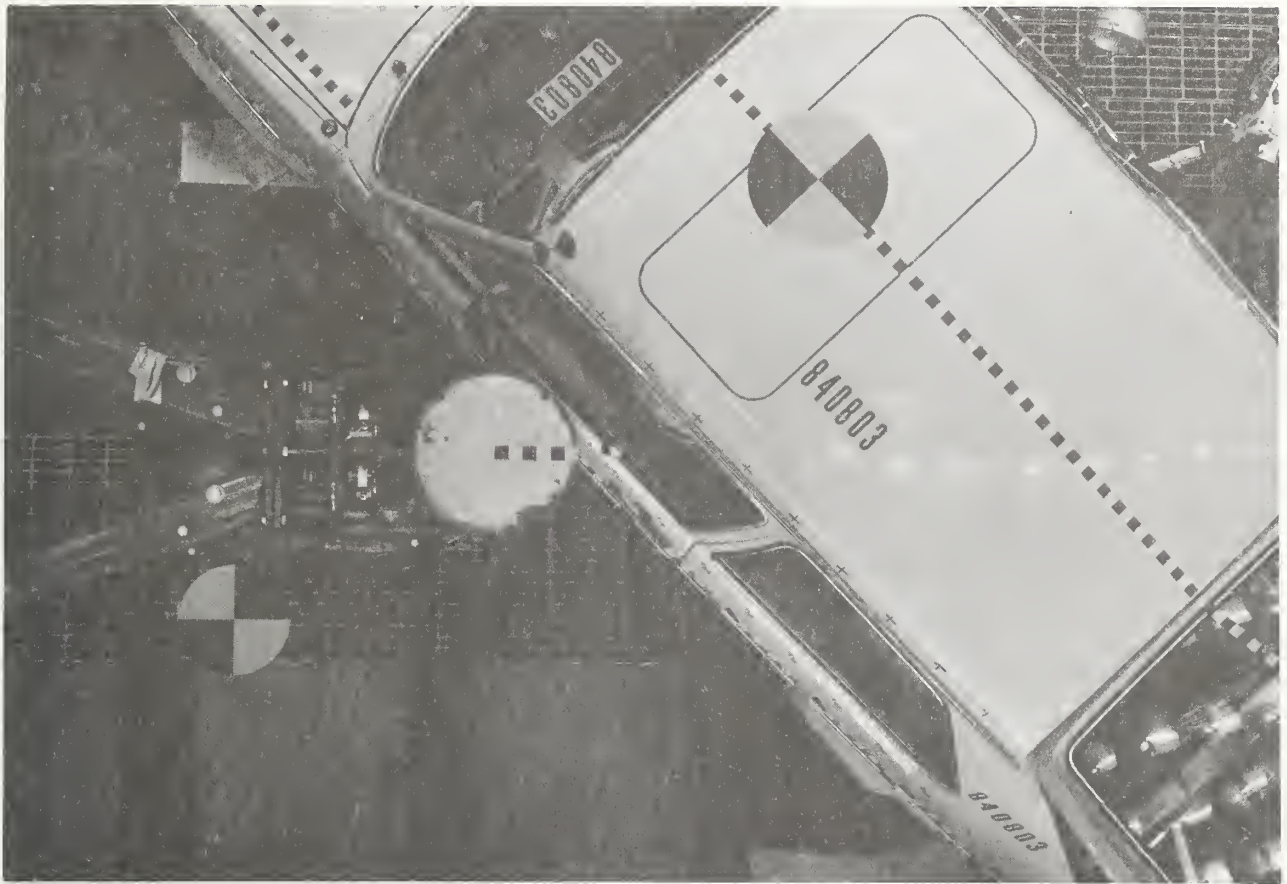
FIGURE 5.1 -- Pre-Test Impact Orientation
of Pole and Baseline Rabbit

It was then judged that the desired loading on the driver's chest accompanied by minimal loading on the head could be achieved by choosing an impact point a small distance behind the driver dummy. Assuming that the dummy's head continued to move in the direction of impact until it reached the pole, an impact location of 6.5" forward of the wheelbase center would result in the back of the head just grazing the forward edge of the pole. An impact location of 6.5" forward of the wheelbase center was therefore selected (see figure 5.1). The impact speed was also raised to 25 mph.

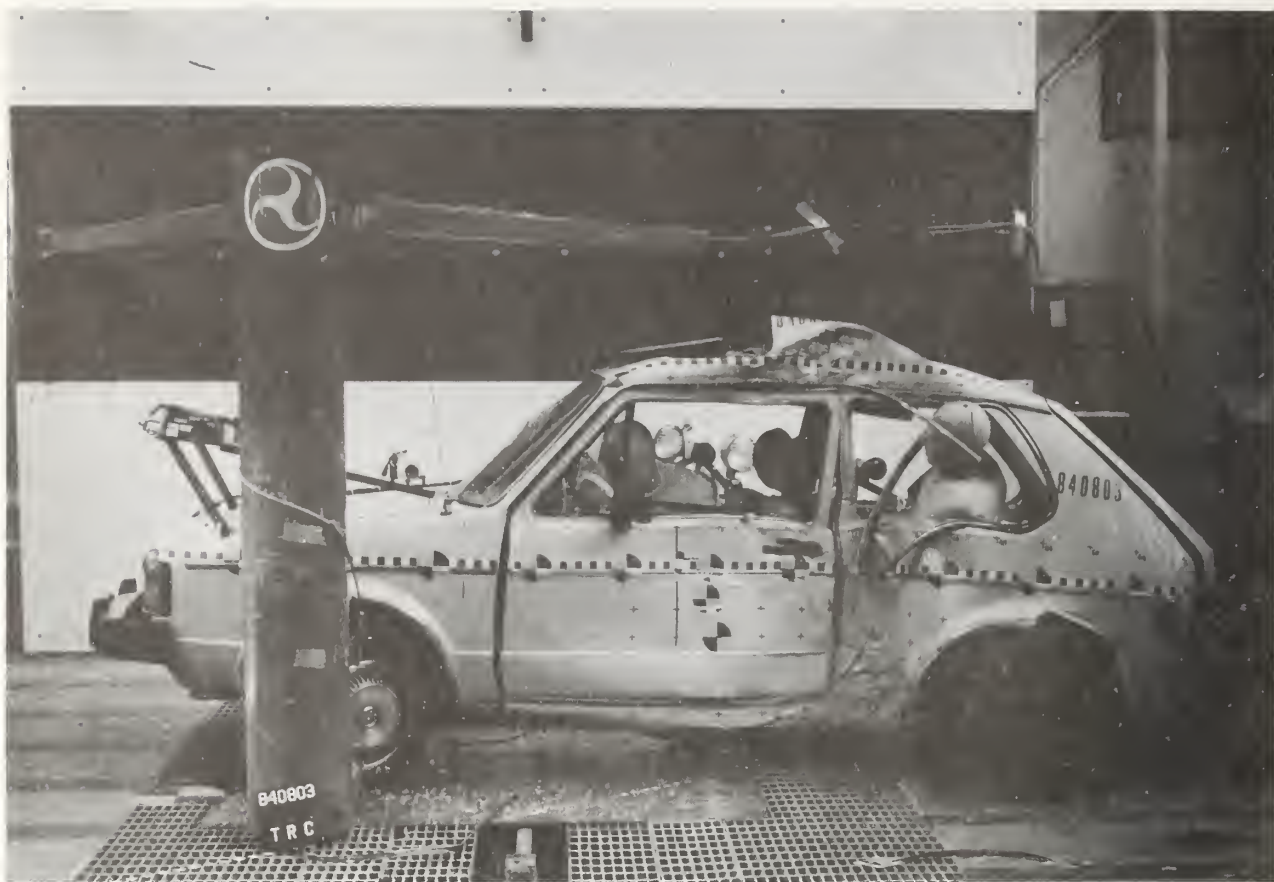
FIGURE 5.2 -- Post-Test Damage of Baseline Rabbit

Figure 5.2 shows the damage to the vehicle used in this test. A maximum intrusion measurement of 19.3" was taken at the mid-door height, 24" rearward of the impact location.

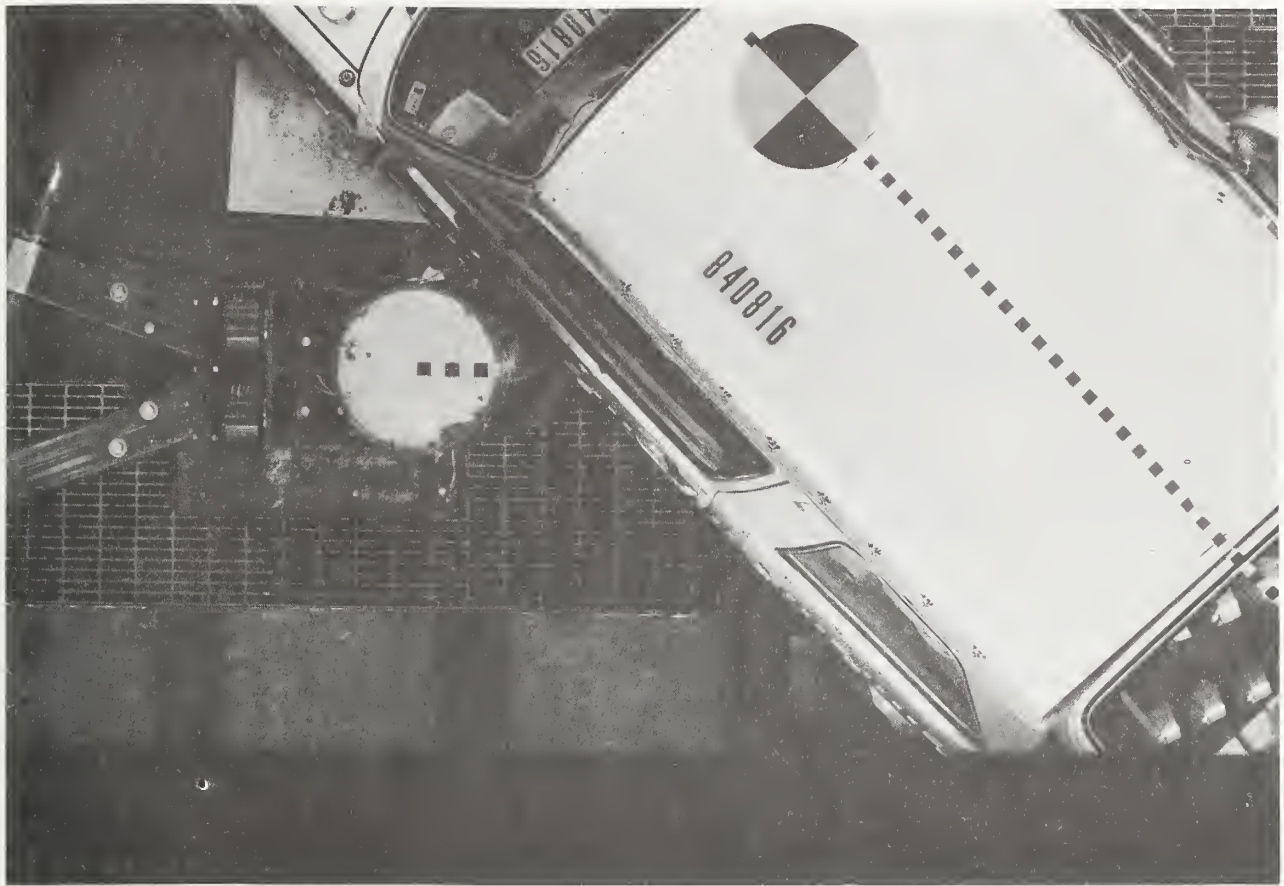
FIGURE 5.3 - Pre-Test Impact Orientation
of Pole and Modified Rabbit

The fourth test repeated the test conditions of the third using a VW Rabbit that had been structurally modified and had an additional inner door padding. When an impact location was selected such that the back of the driver dummy's head would just graze the forward edge of the pole, it was found to be 9" forward of the wheelbase center. The difference between this and the previous test was believed to be due to the differences between the early model modified Rabbit used for this test and the later models used in the first three tests. It was judged that the position of the pole relative to the dummy seating position was more crucial than that relative to the wheelbase center, so an impact location of 9" was chosen (see figure 5.3). Once again, impact speed was to be 25 mph.

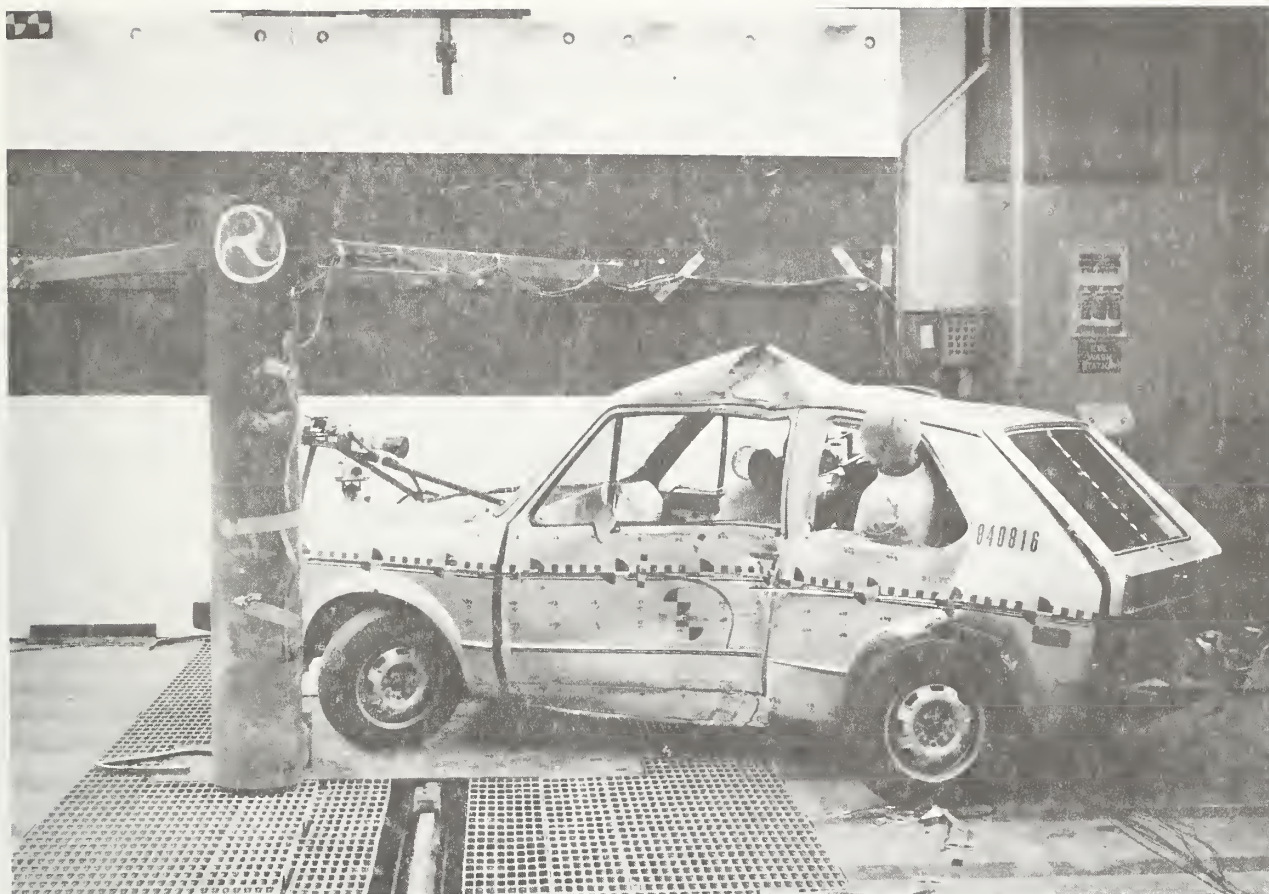
FIGURE 5.4 -- Post-Test Damage of Modified Rabbit

Figure 5.4 shows the damage to the vehicle used in this test. A maximum intrusion measurement of 17.3" was taken at the mid-door height, 12" rearward of the impact location.

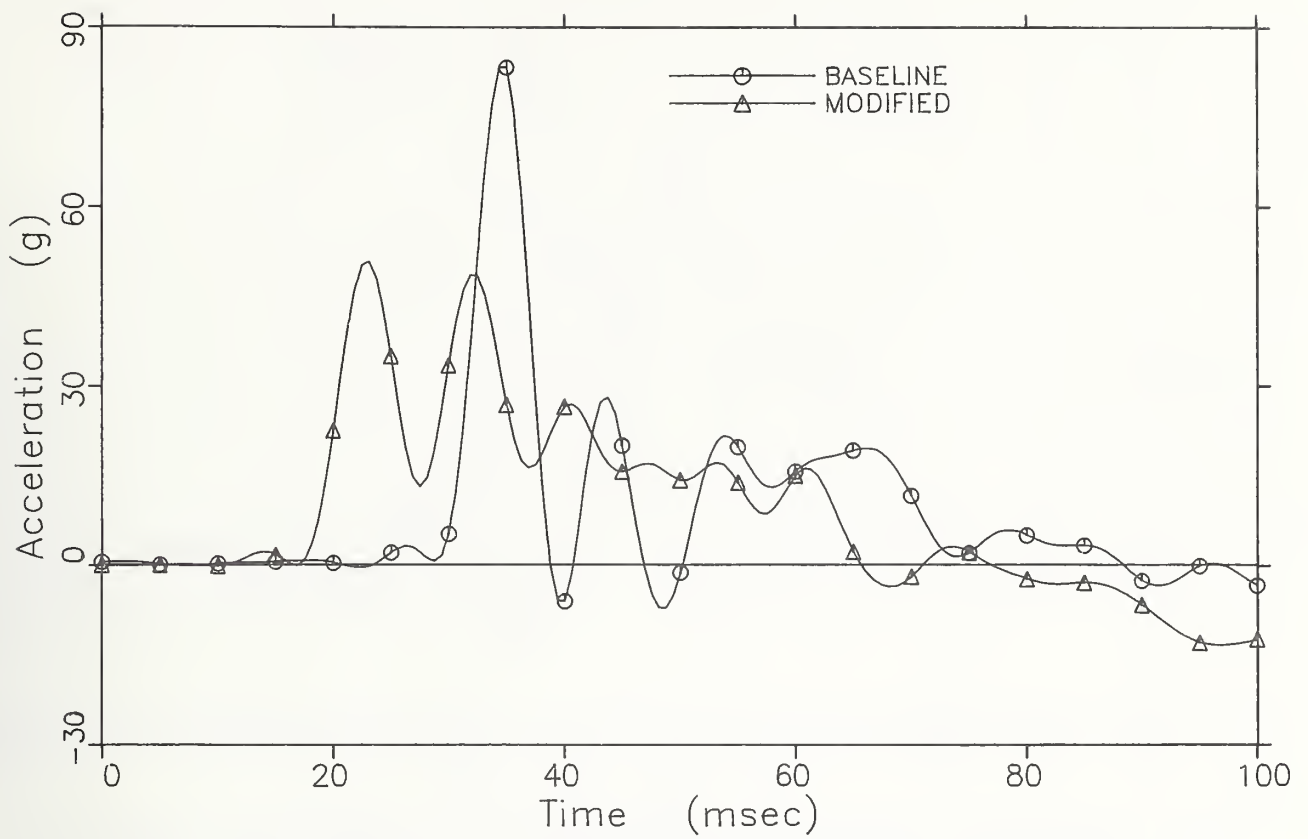
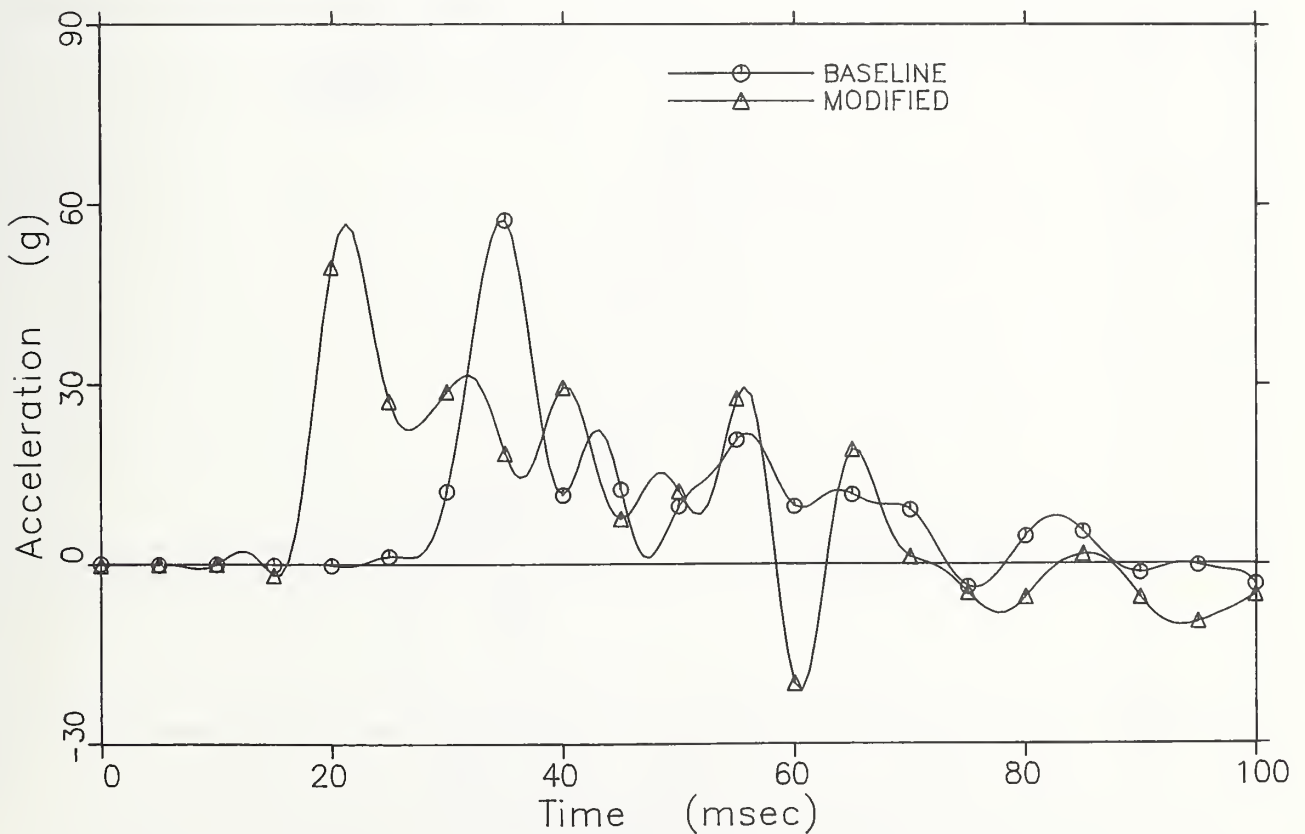
POLE TESTS — DRIVER — LEFT UPPER RIB

POLE TESTS — DRIVER — LEFT LOWER RIB

FIGURE 6.1 -- Comparisons of Driver Rib Acceleration Responses

The peak lateral dummy responses from table 5.1 were generally lower in the modified car test than they were in the comparable baseline car test. For the driver, peak upper rib accelerations were lowered from 83.5 to 50.8 g's (39%), while lower rib responses went from 57.5 to 56.9 g's (1%). Also for the driver, upper spine readings decreased from 67.0 to 63.7 g's (5%), while those of the lower spine went from 85.5 to 73.0 g's (15%). Driver pelvic accelerations dropped from 67.0 to 55.2 g's (18%). It should be noted that the accuracy of the accelerometers used in these tests was $\pm 5\%$. Figures 6.1 through 6.5 are overlay plots of these responses.

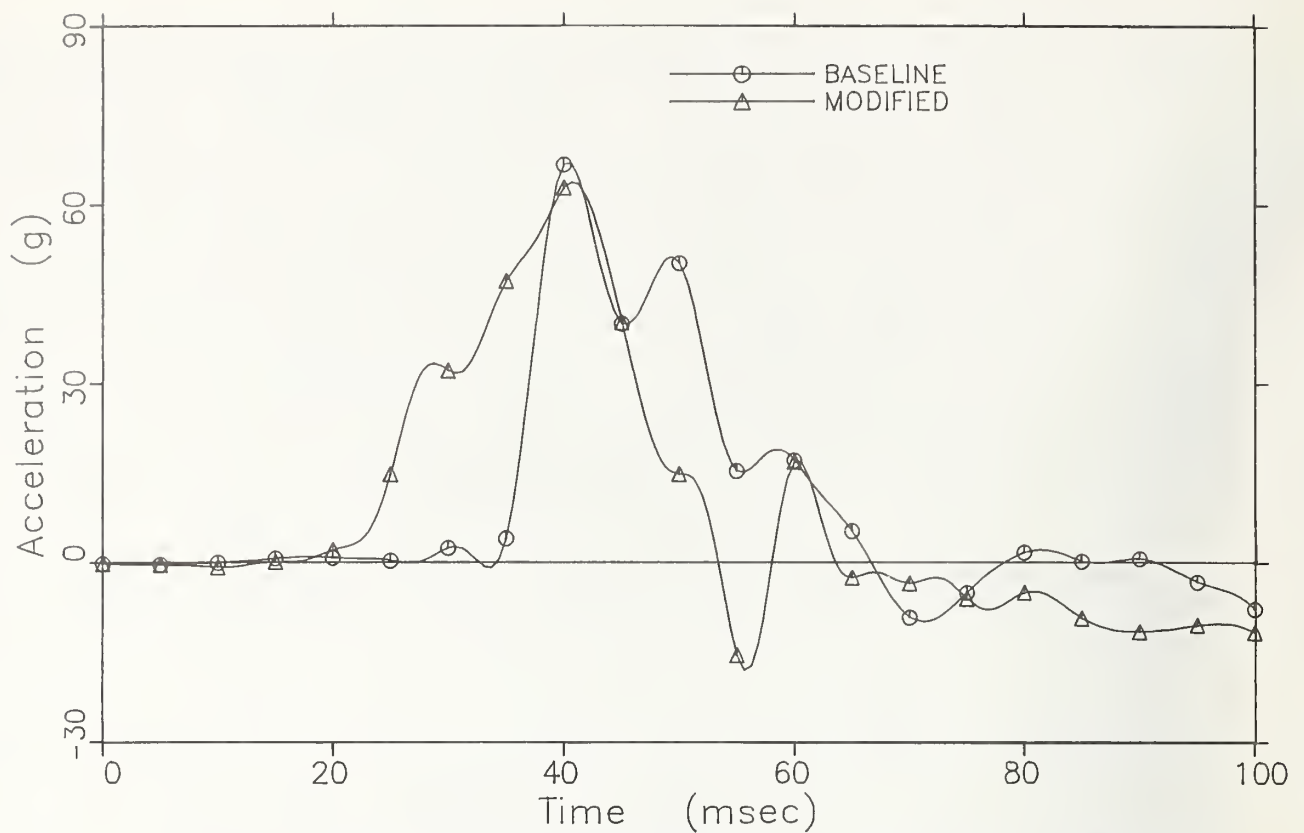
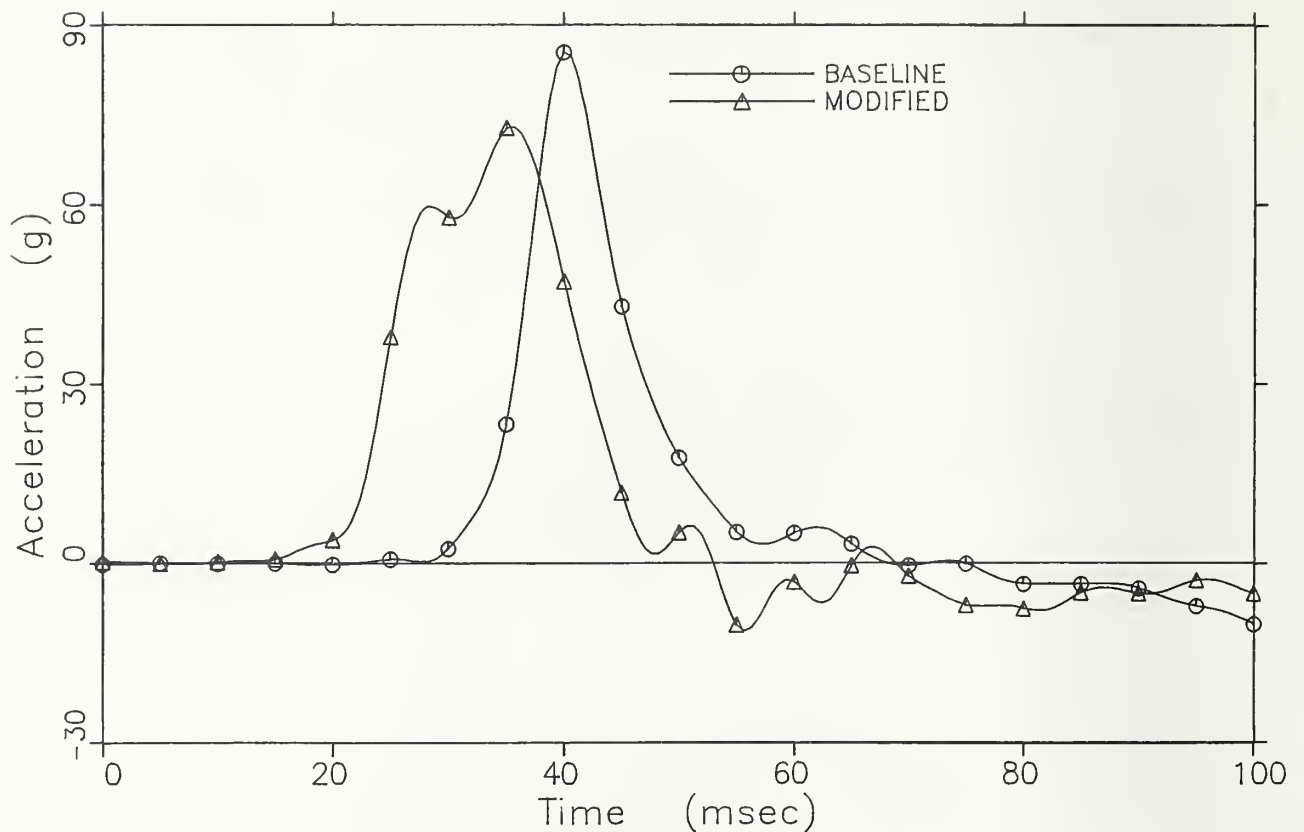
POLE TESTS — DRIVER — UPPER SPINE

POLE TESTS — DRIVER — LOWER SPINE

FIGURE 6.2 -- Comparisons of Driver Spinal Acceleration Responses

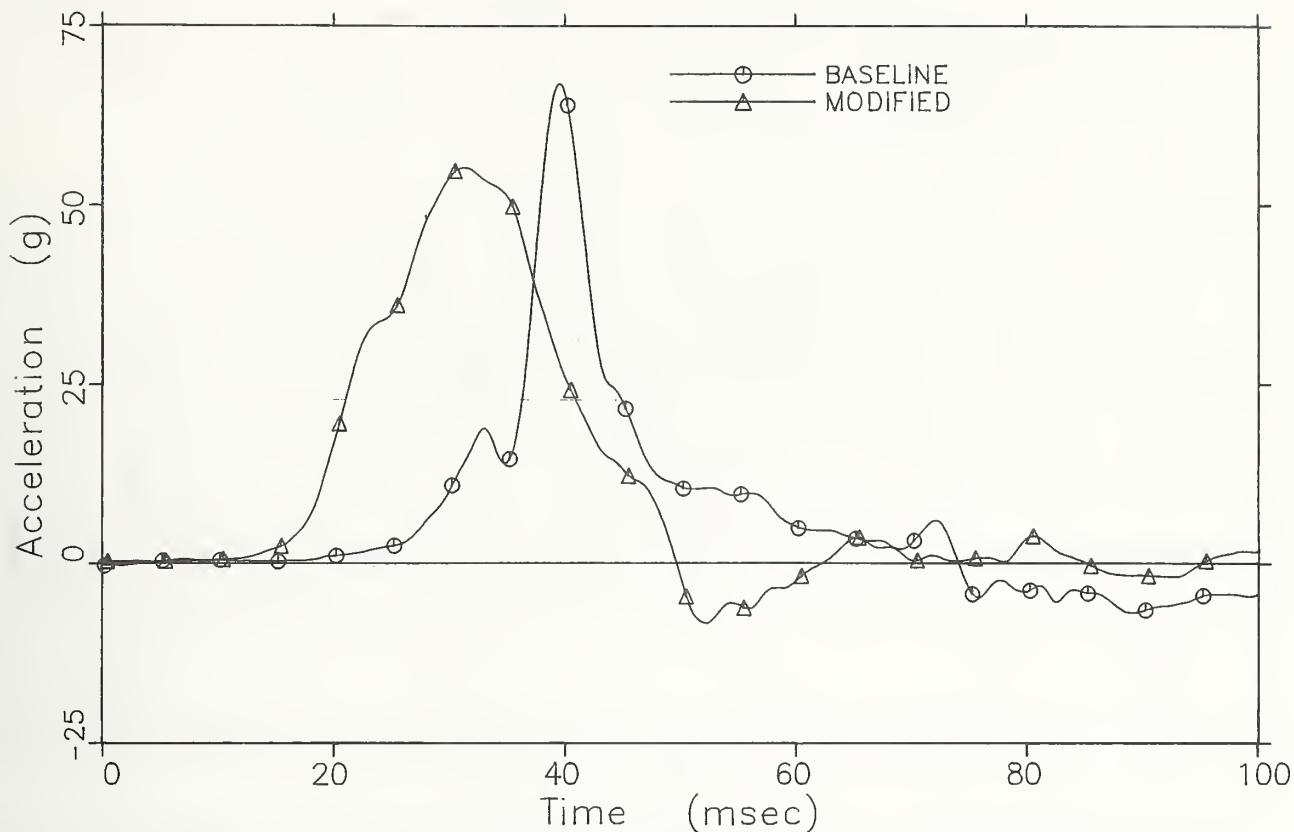
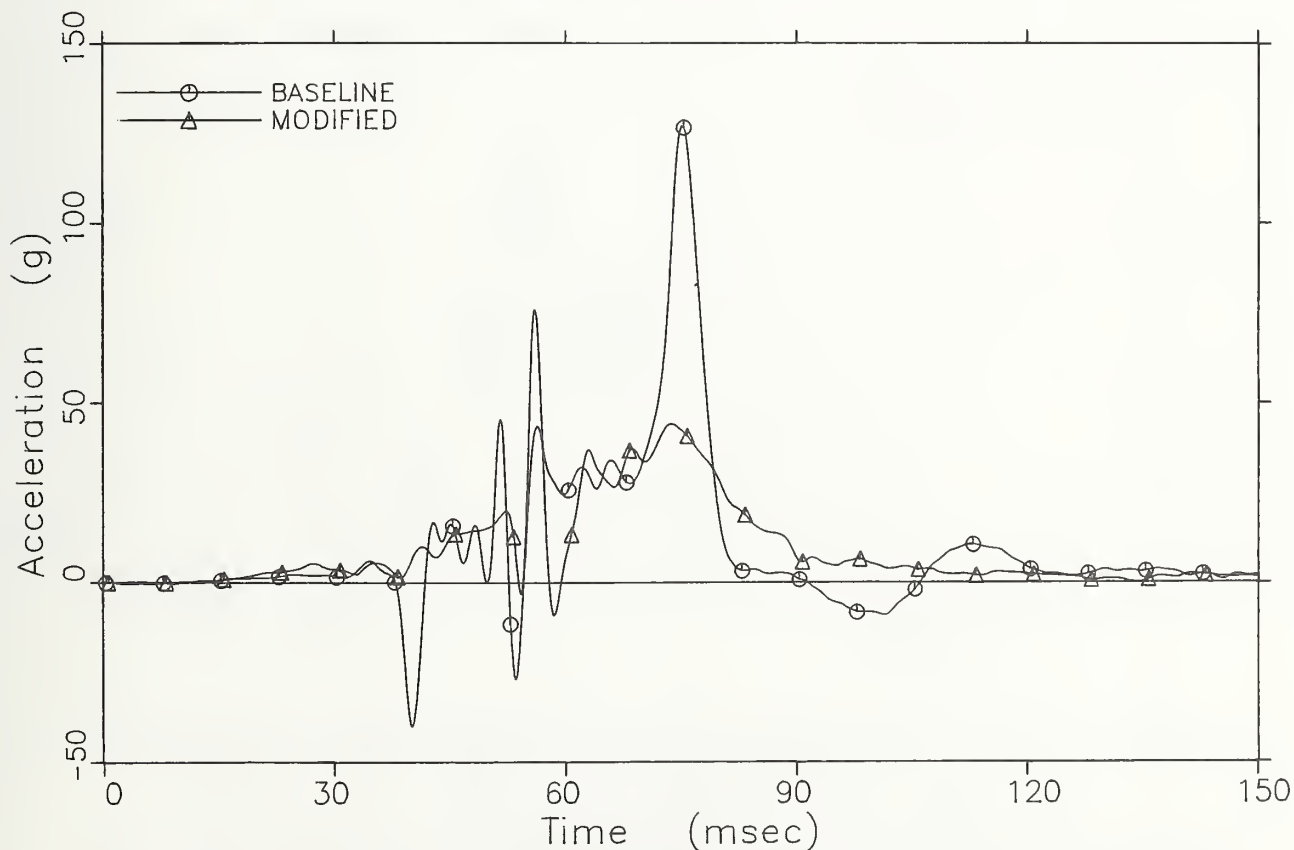
POLE TESTS - DRIVER - PELVIS

POLE TESTS - PASSENGER - PELVIS

FIGURE 6.3 -- Comparisons of Driver and Passenger Spinal Acceleration Responses

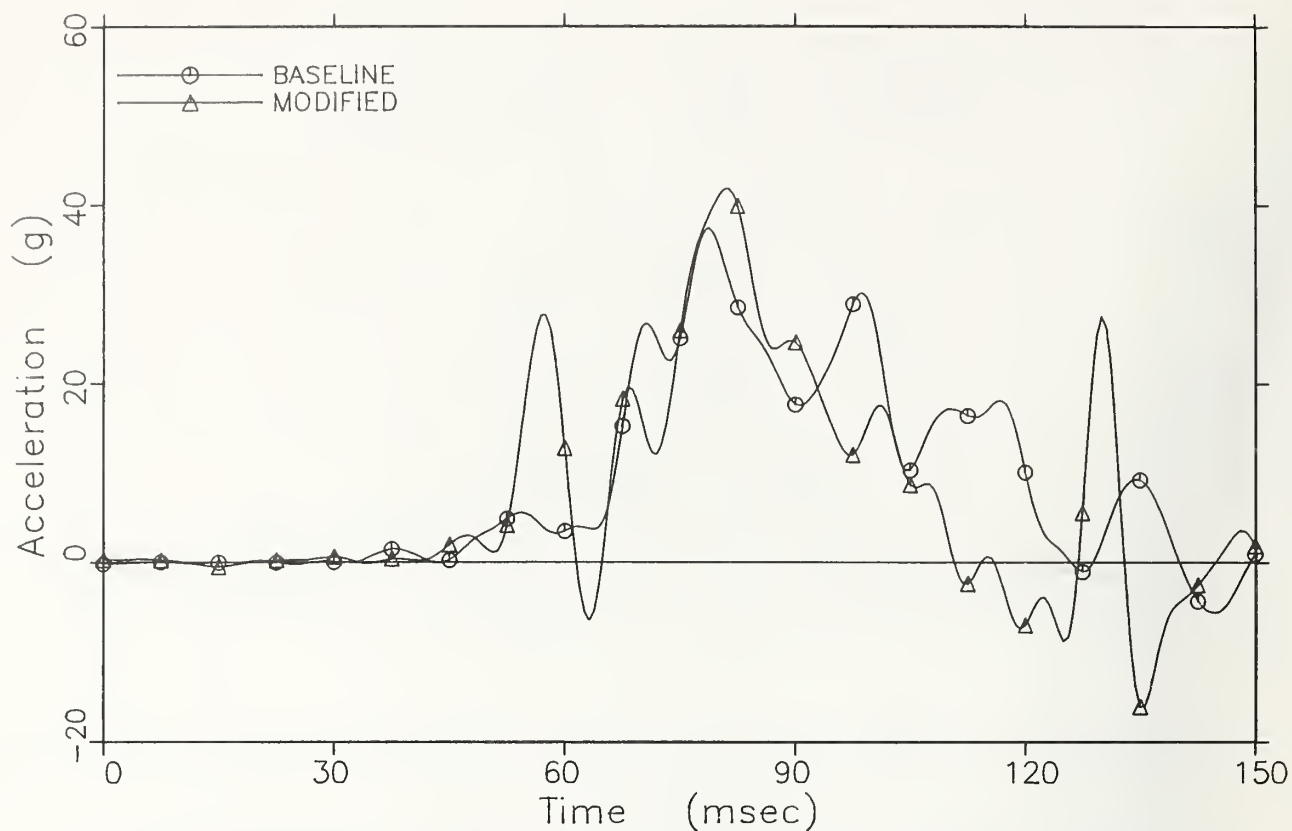
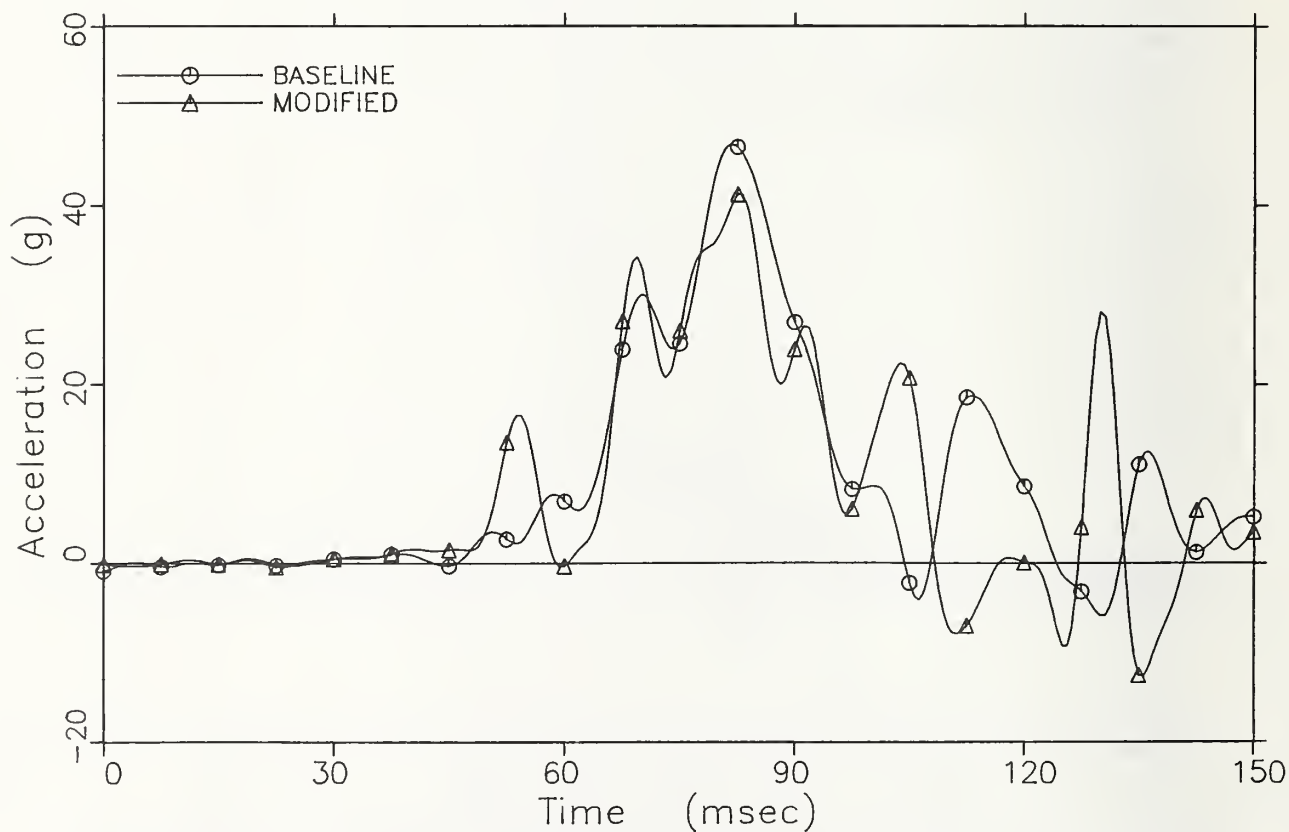
POLE TESTS — PASSENGER — LEFT UPPER RIB

POLE TESTS — PASSENGER — LEFT LOWER RIB

FIGURE 6.4 -- Comparisons of Passenger Rib Acceleration Responses

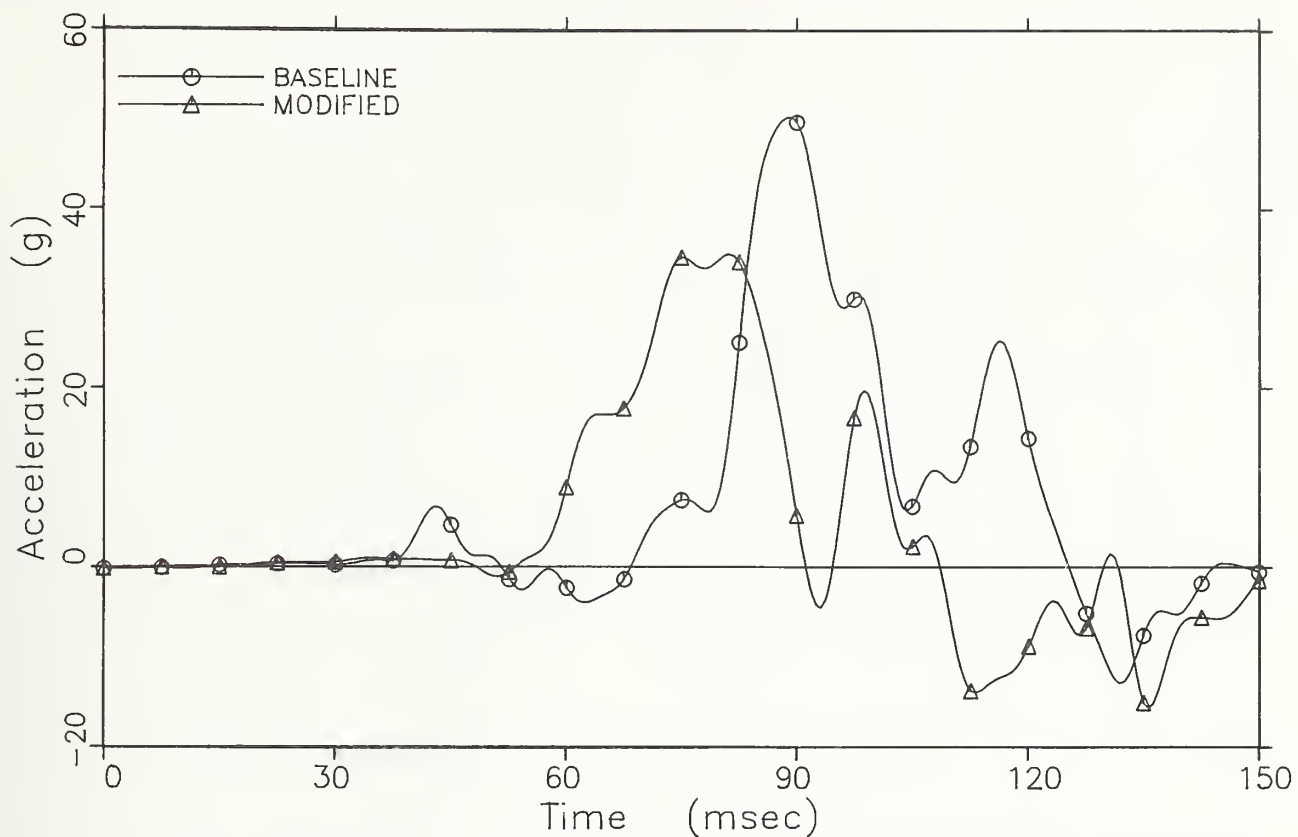
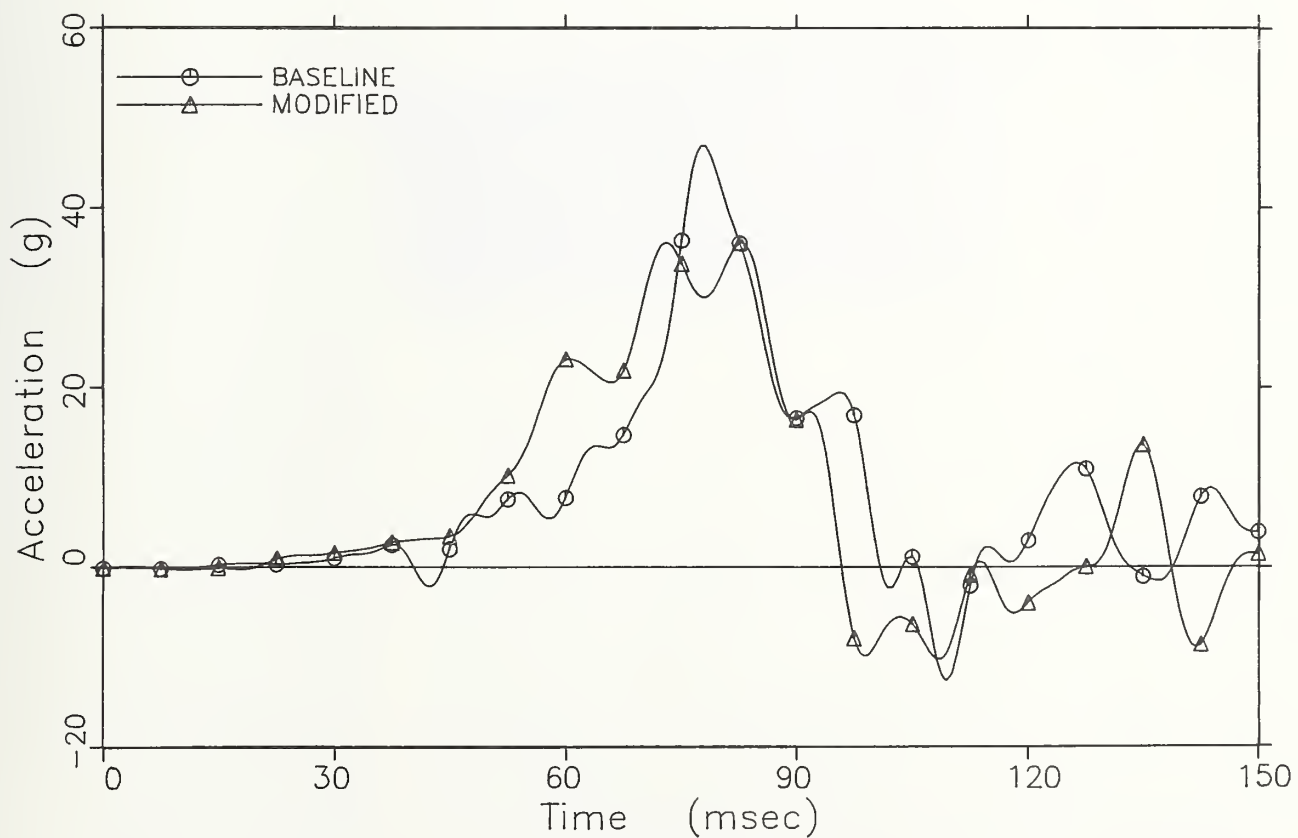
POLE TESTS — PASSENGER — UPPER SPINE

POLE TESTS — PASSENGER — LOWER SPINE

FIGURE 6.5 -- Comparisons of Passenger Spinal Acceleration Responses
